# DESIGN AND CONSTRUCTION OF AN AVALANCHE DEFLECTING BERM, MOUNT KITCHENER AVALANCHE PATH, AORAKI MOUNT COOK NATIONAL PARK, NEW ZEALAND

**ABSTRACT:** The Mount Kitchener avalanche path produces large avalanches that have potential to affect parts of Aoraki Mount Cook Village, New Zealand. Numerous buildings located in the runout zone could be affected by avalanches, including the iconic Hermitage Hotel and several residences. Although there is no historical evidence of destructive avalanches reaching the village, statistical and dynamic avalanche modelling combined with field evidence confirmed the potential for Destructive Size 4 or 5 avalanches to reach the village with a return period between 100 and 300 years. The potential runout position of the dense component of 100 to 300-year avalanches was determined to be within the limits of the village. Powder avalanches could penetrate further into the village, as has been evidenced by historical events. Potential impact pressures within the village were estimated in the range of 1 to 70 kPa. The existing 2 m high deflection berm constructed on the debris fan has been overtopped on numerous occasions and was determined to be ineffect

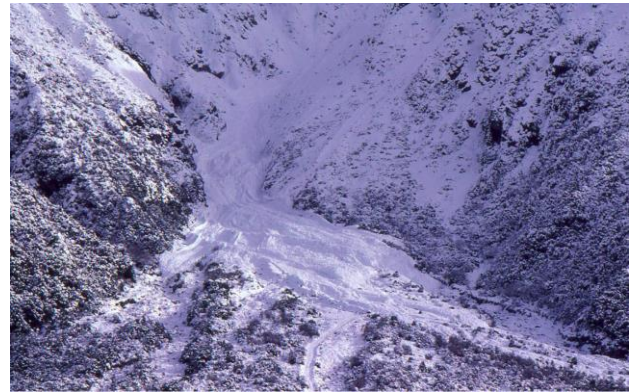
Figure 5: Avalanche debris onto the Kitchener fan in 1995. Debris covered approximately 2.7 ha with 70,000-90,000 m<sup>3</sup> of debris, some of which overtopped the original diversion berm.

Investigations and historical observations of avalanches in the path led to the conclusion that the existing 2 m high berm was only effective for relatively small avalanches and could be easily overtopped by larger (Size D3 or D4) avalanches. This is illustrated by events in 1995 (Figure 5) and 2009 (Figure 6).

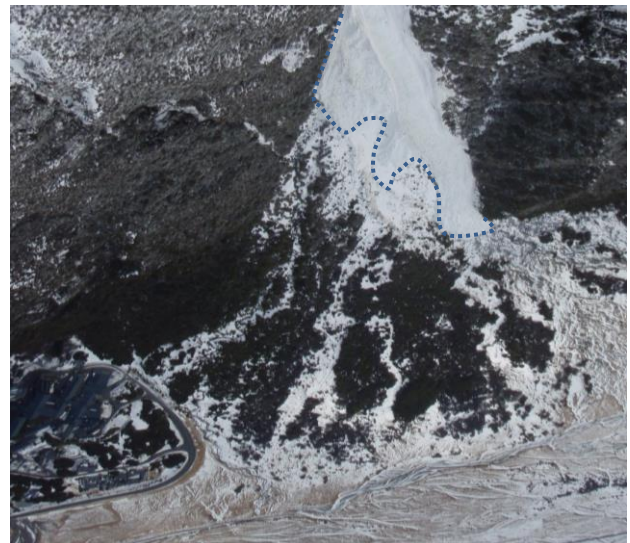
Figure 6: Avalanche in the Kitchener path, 24 July, 2009. Dashed blue line delineates approximate toe of deposit which overtopped the diversion berm (DOC photo).

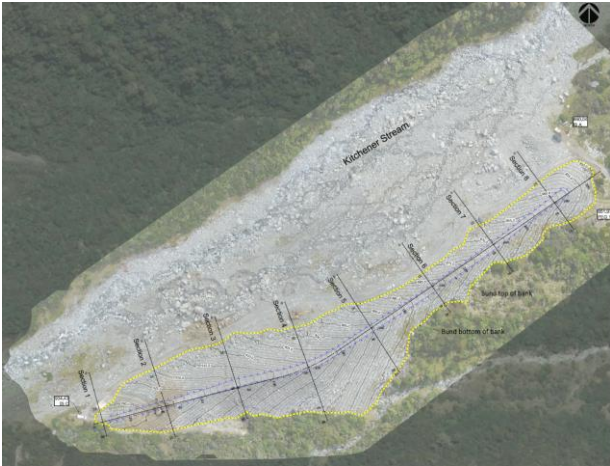
Figure 8: As-built diversion berm in plan view.

The final cost of the project was NZ \$700,000 (€430,000). An as-built survey was completed, which showed the final constructed fill to be 46,369 m<sup>3</sup>, with construction as per the original design concept (Figure 8). Figures 9 through 11 show three views of the completed structure.

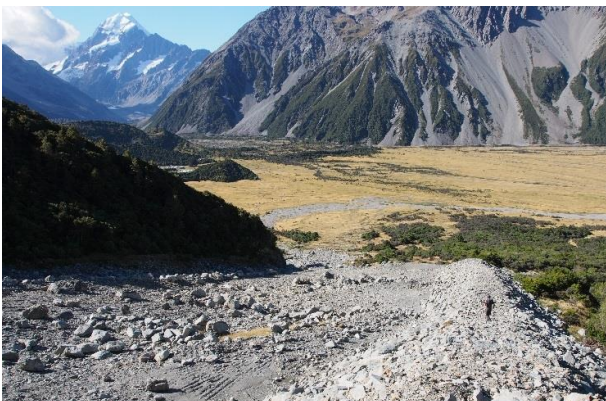
Figure 9: Completed diversion berm looking downslope.

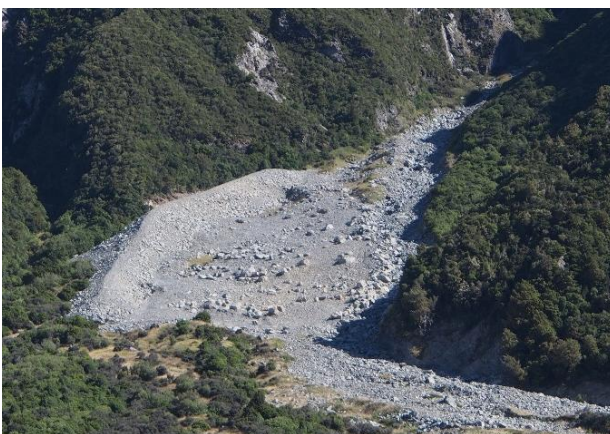
Figure 10: Completed diversion berm.

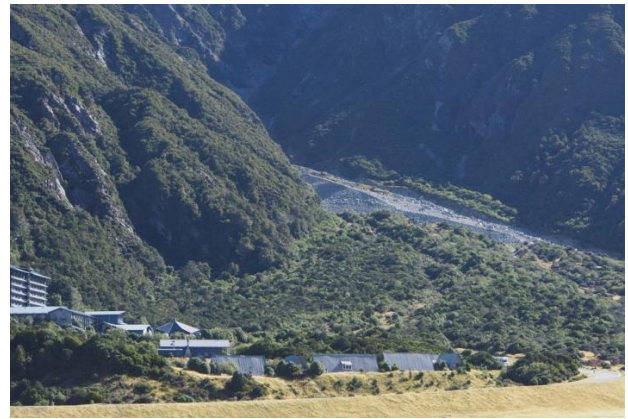
Figure 11: Completed diversion berm viewed from Aoraki Mt. Cook Village.
